ENVIRONMENTAL AUDIT REPORT

GITAM UNIVERSITY

Nagadinahalli, Bengaluru

Document number	Rev	Date	Done by	Checked by	Approved by
CCPL/Cx/GITAM-BLR/Env Audit	00	16.02.22	RKA	KGB	SVK

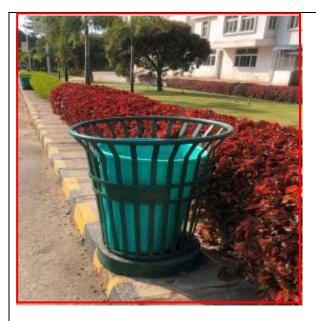
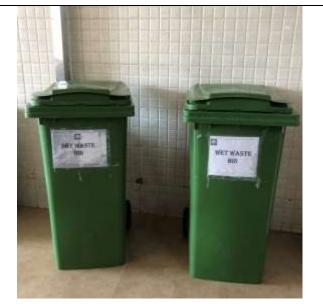
Different type waste collection bins are kept for the collection of waste.

This helps in reducing the segregation of waste at source.

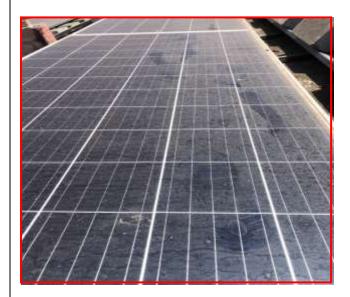
Site Observation Report (SOR)								
Report No.	C&A/SOR/07	Date	10.02.2022					
Location	Admin 1 & 2 Blocks, Staff Quarters Roof Top (498 kW Solar PV Panels)

Dusts on Solar PV panels were observed.

It is highly recommended to clean the Solar PV Panel at manufacturer recommended intervals better power generation efficiency.

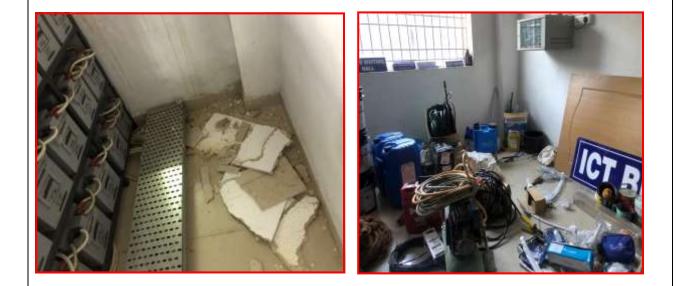
Site Observation Report (SOR)								
Report No. C&A/SOR/12 Date 10.02.2022								
Location	Admin Block 1& 2 – UPS Batte	ery Roon	ns					
Observation Images

It is observed that conditioned UPS battery rooms are accumulated with more waste items, dust and debris.

It is advised to keep the conditioned UPS battery rooms clean. And install exhaust fans and Hydrogen sensors in the battery rooms.

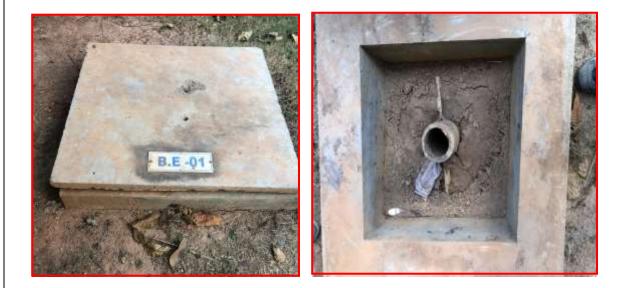
Site Observation Report (SOR)								
Report No. C&A/SOR/13 Date 10.02.2022								
Location	Admin Block -2 Backside							
Observation Images

It is observed that body earth is conventional type. University's Earthing system must be in better condition as it is prone to malfunction and gives rise to harmonic and multiply the same into the electrical network.

It is recommended to plan for maintenance free Earthing instead of the conventional Earthing.

And also location should be mentioned along with B.E -01 no.

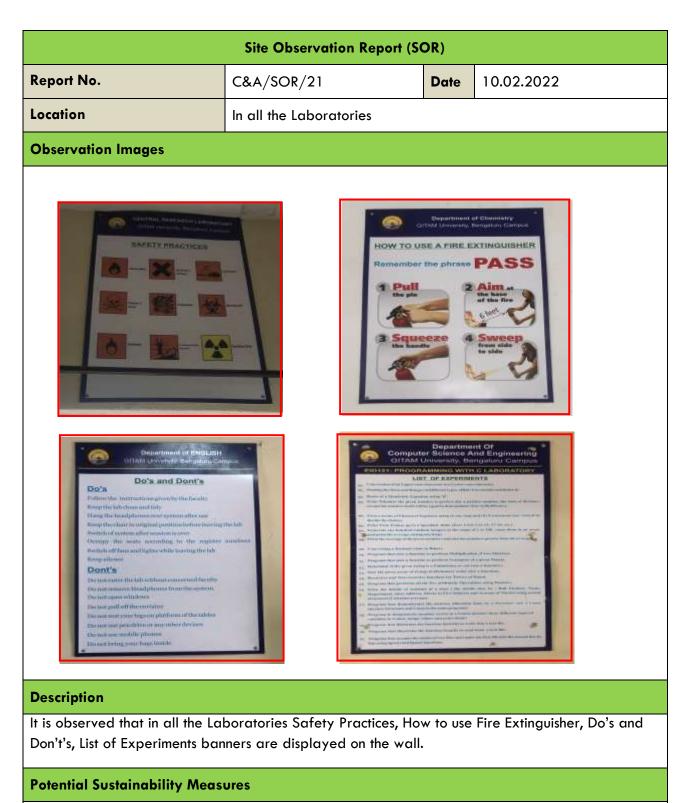
It is highly encouraged practices in the Laboratories, which creates awareness and safety measures on how to handle the experiments among the students.
